Home Inspection Report

0000 Great St, Knoxville, TN 00000

Wednesday November 1, 2017

Bright Light Home Inspections
(865) 770-1987

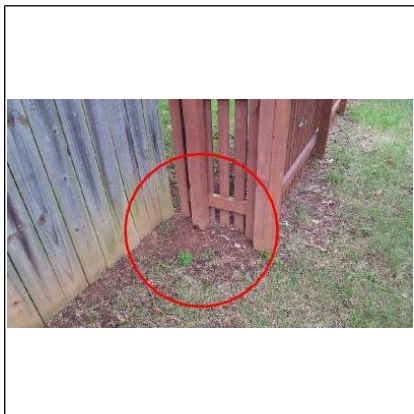
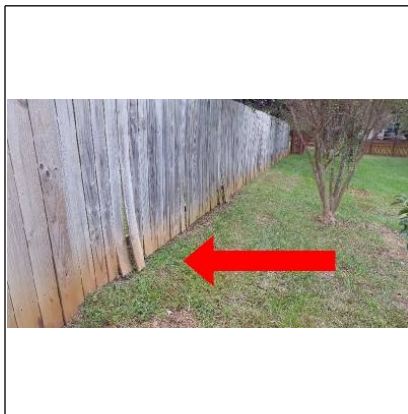
Grounds

Comments Deck wood 4x4 piers in contact with soil and will liit life of supports due to rot.

Comments West side red fence post has some rot where wood makes contact with earth. Some are loose on bottom. There are 1 x 6 slats warped on Back Fence. West side gate rubbing on ground. These are typical wear for the age. Recommend repair.

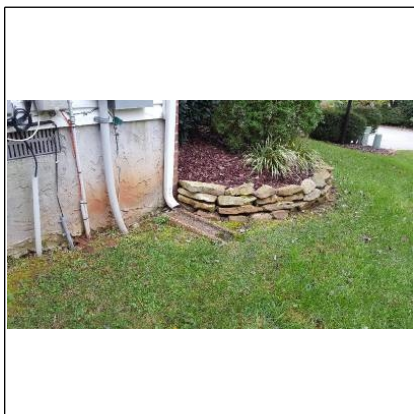
Negative Grade East West North South Satisfactory Recommend additional backfill
 Recommend window wells/covers Trim back trees/shrubberies
 Wood in contact with/improper clearance to soil

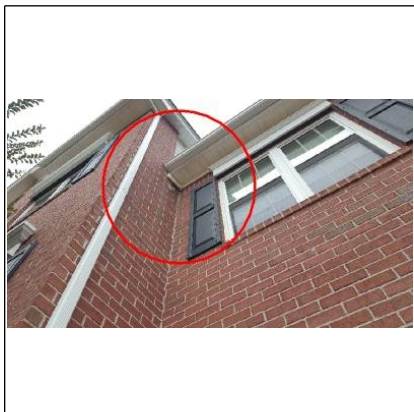
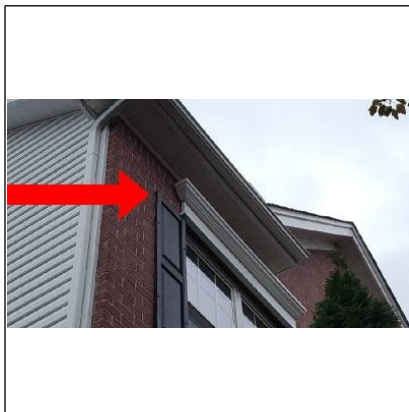
Exterior

Comments Some loose trim. recommend repair

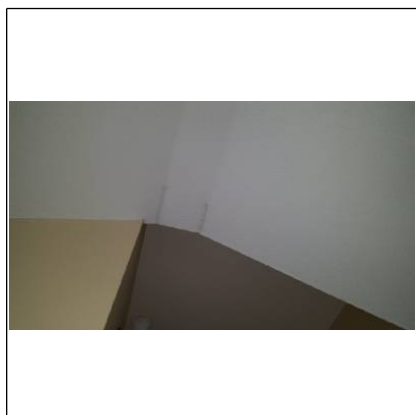
Comments Stress cracks at crown of ceiling. These are cosmetic . Recommend repair.

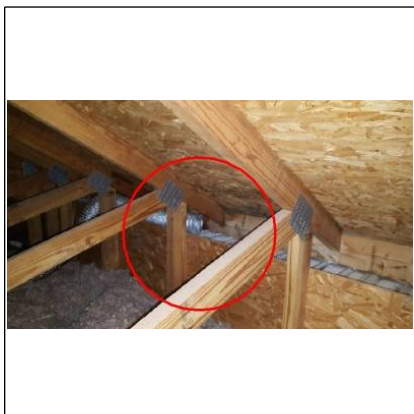
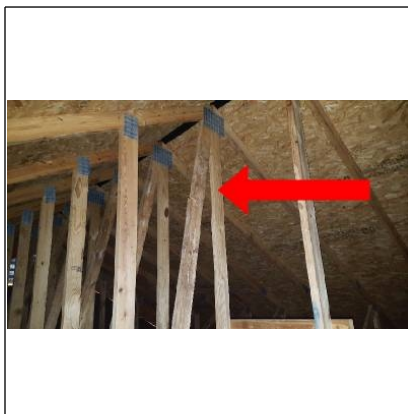
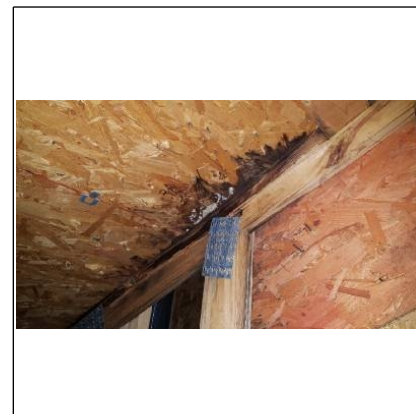
Comments Cracked rafter was noted in the attic recommend repair
 Insulation was sufficient for homes in this area.
 Recommend extending bathroom vents to the exterior.

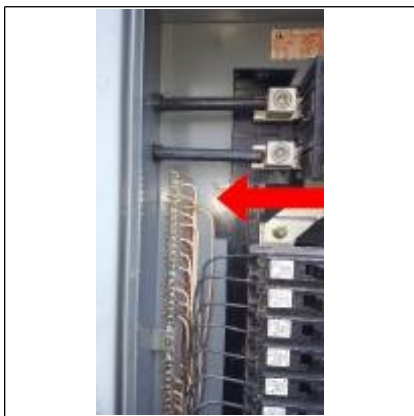
Reason: Box allows double tapping of 14 or 12 gauge copper wire. But there is a triple tap on busbar. Recommend repair
